**LITTLE LAKE DAM
JEFFERSON COUNTY, MISSOURI
MO. 30456**

**PHASE I INSPECTION REPORT
NATIONAL DAM SAFETY PROGRAM**

SUBJECT: Little Lake Dam (Mo. 30456) Phase I Inspection Report

Name of Dam: Little Lake Dam,
Missouri Inventory No. 30456
State Located: Missouri
County Located: Jefferson
Stream: Unnamed tributary of Joachim Creek
Date of Inspection: May 8, 1981

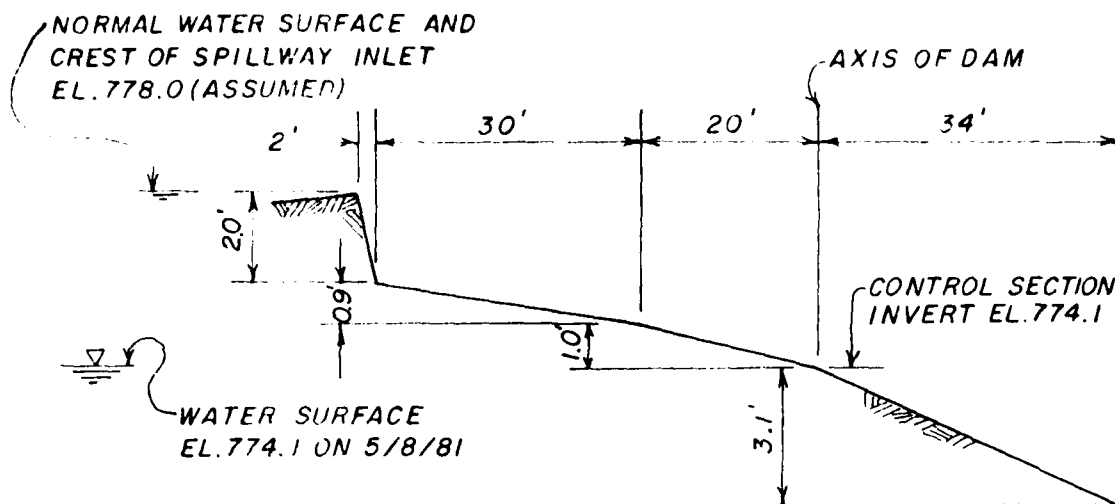
SECTION A-A
(SPILLWAY PROFILE)

The overall condition of the dam appears to be poor due to the seepage at the damsite and the severe erosion in the spillway channel. Both of these conditions jeopardize the safety of the dam and will require prompt attention. Other deficiencies noted by the inspection team, which will require remedial measures, included: the trees and brush on the embankment; a need for periodical maintenance of the grass cover; and a lack of a maintenance schedule. There also exists a need for periodic inspection by a qualified engineer. The lack of seepage and stability analyses on record is also a deficiency that should be corrected.

It is recommended that the owner take action to correct or control the deficiencies described above. Replacement of the present spillway with a more stable and erosion-free spillway and further investigation of the seepage warrant prompt attention and should be pursued on a high priority basis. All other remedial measures should be undertaken within a reasonable period of time.
